**Maryland**  
Department of  
the Environment

Subject: Dam Inspection Findings  
Emmitsburg Dam (MD Dam No. 18)

# **INSPECTION REPORT**

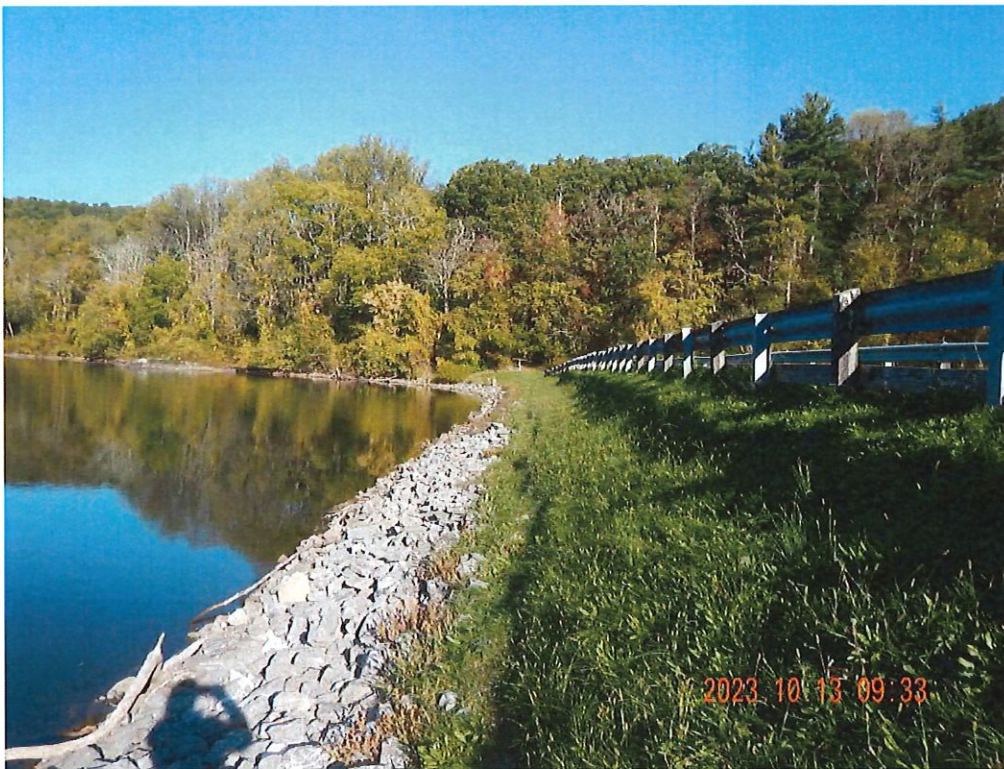
Photo 1 description: Upstream Slope Left Side

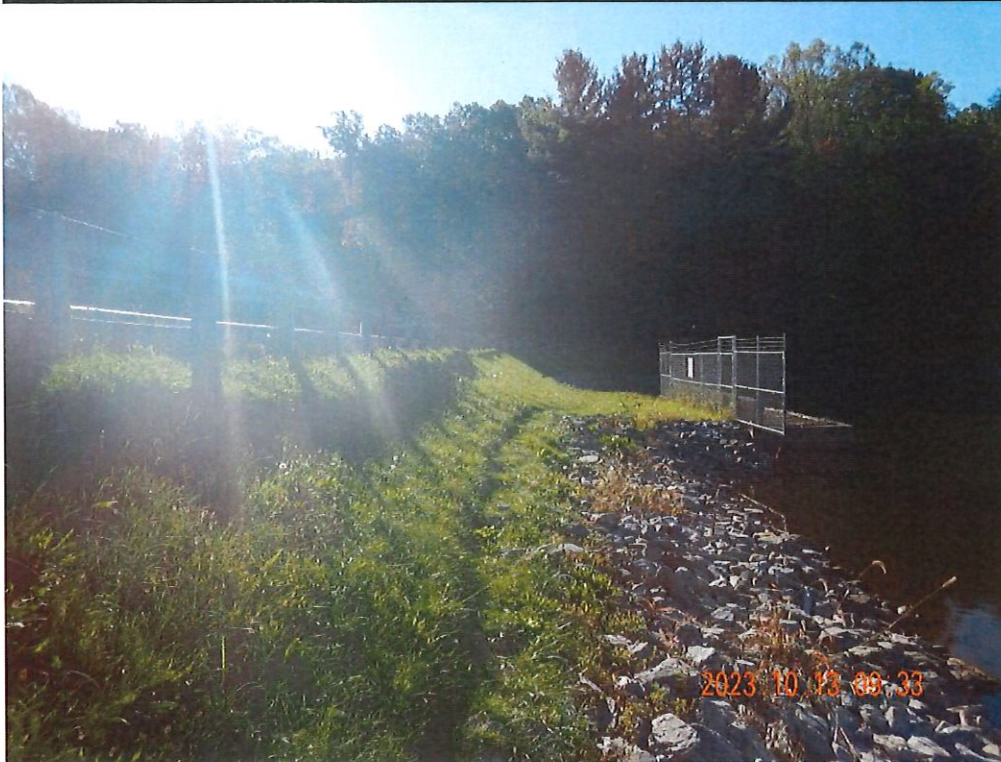
Photo 2 description: Upstream Slope Center

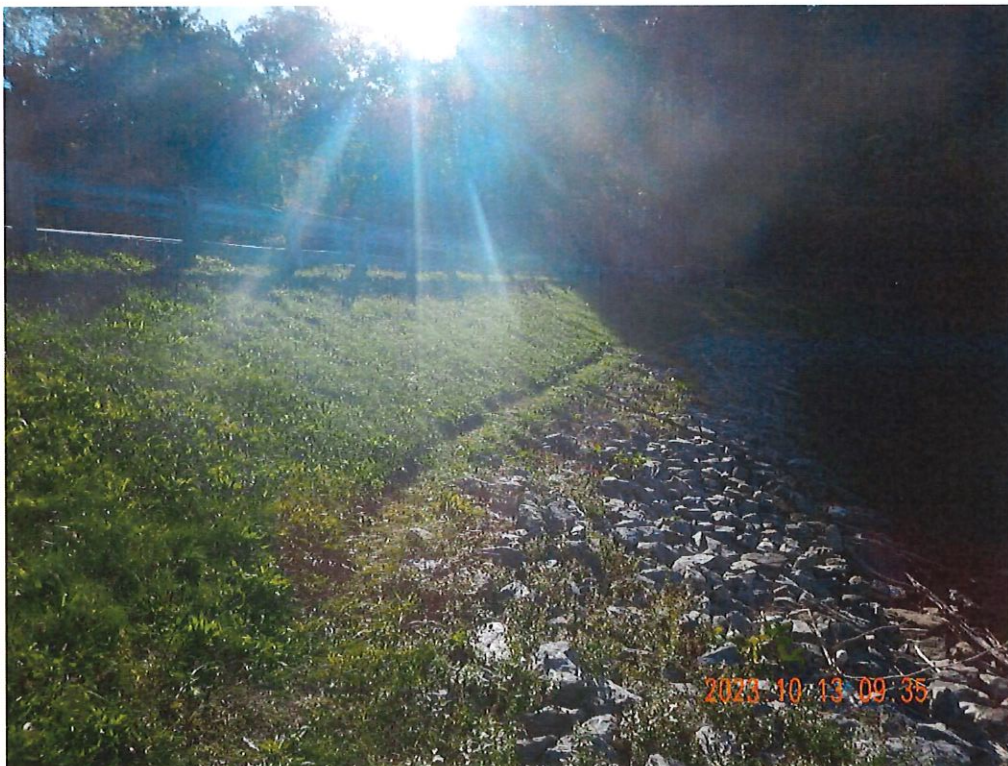
Photo 3 description: Upstream Slope Right Side

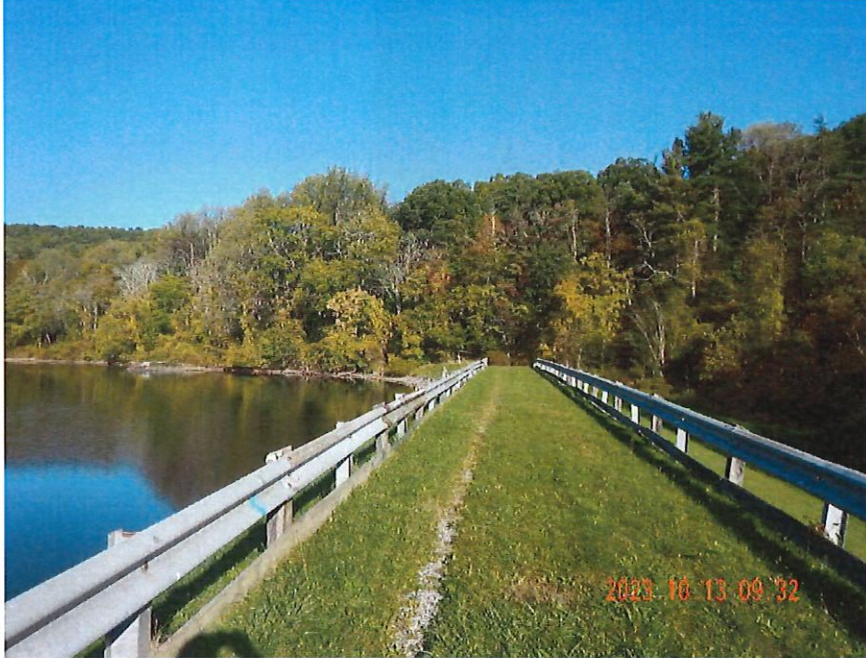
Photo 4 description: Crest Left Side

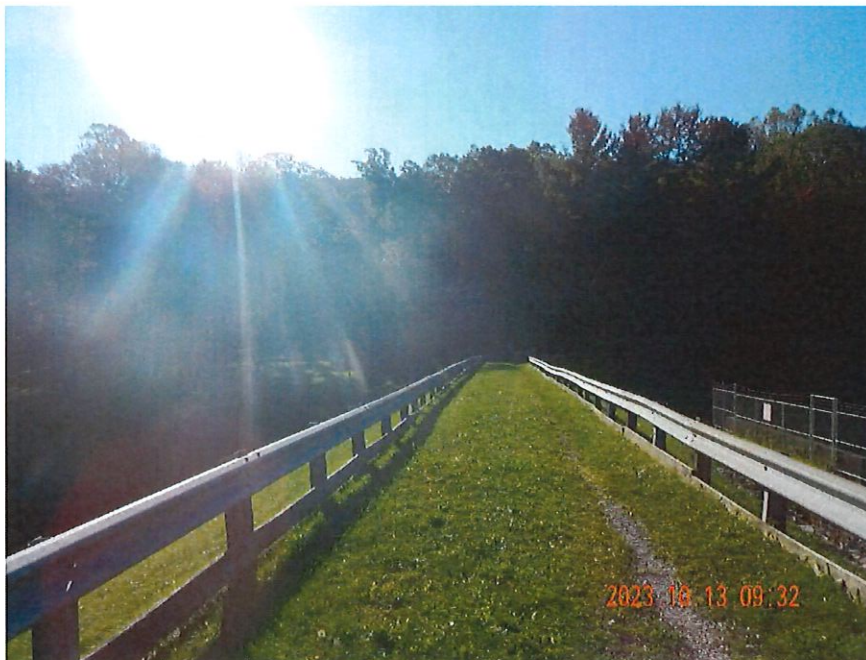
Photo 5 description: Crest Right Side

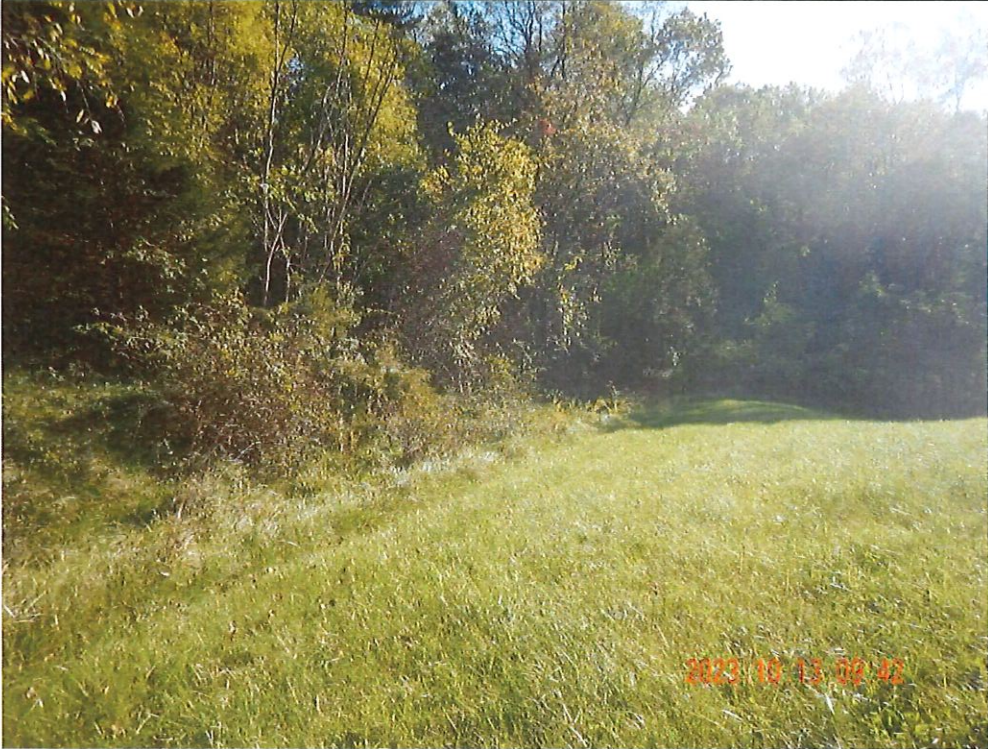
Photo 6 description: Downstream Slope Left Abutment

**Describe action required:** Remove woody vegetation (trees and shrubs) with a diameter less than six (6) inches at chest height within 15 feet of the downstream toe of slope and outlet. Please refer to Policy Memorandum No. 1 – Maintenance and Repair Trees and Woody Vegetation for additional guidance. Please retain a professional engineer experienced in dam inspections, design and construction to evaluate removal of woody vegetation with diameters greater than 6 inches at chest height within 15 feet of the downstream toe of slope and outlet and make recommendations.

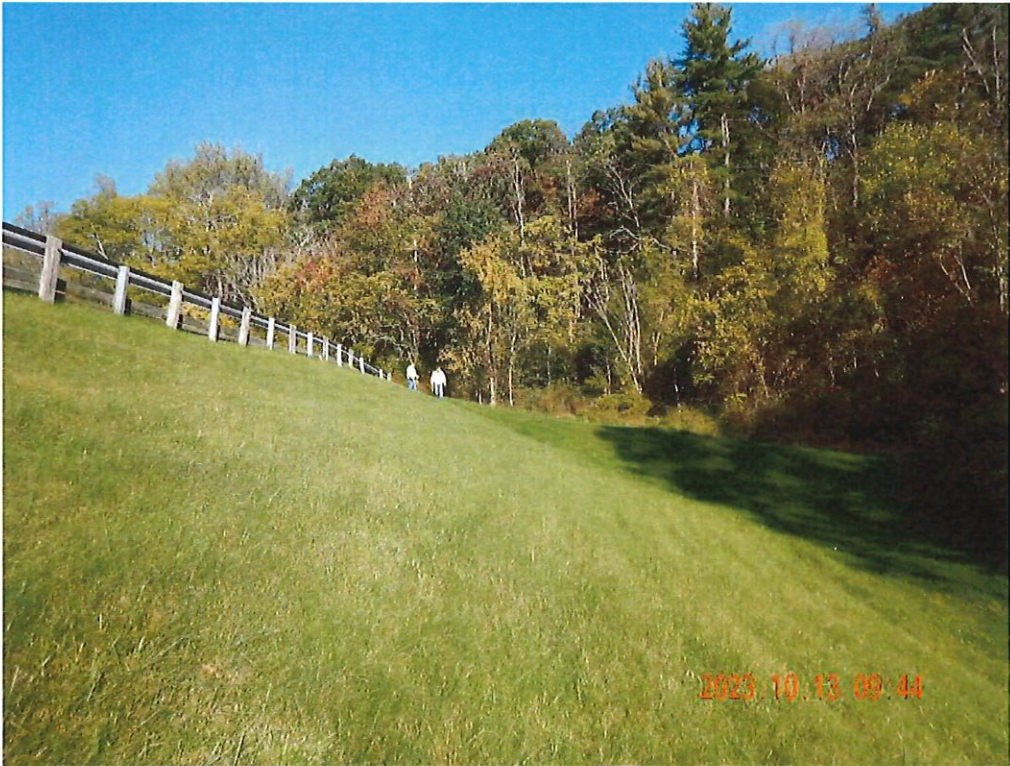
Photo 7 description: Downstream Slope Left Side

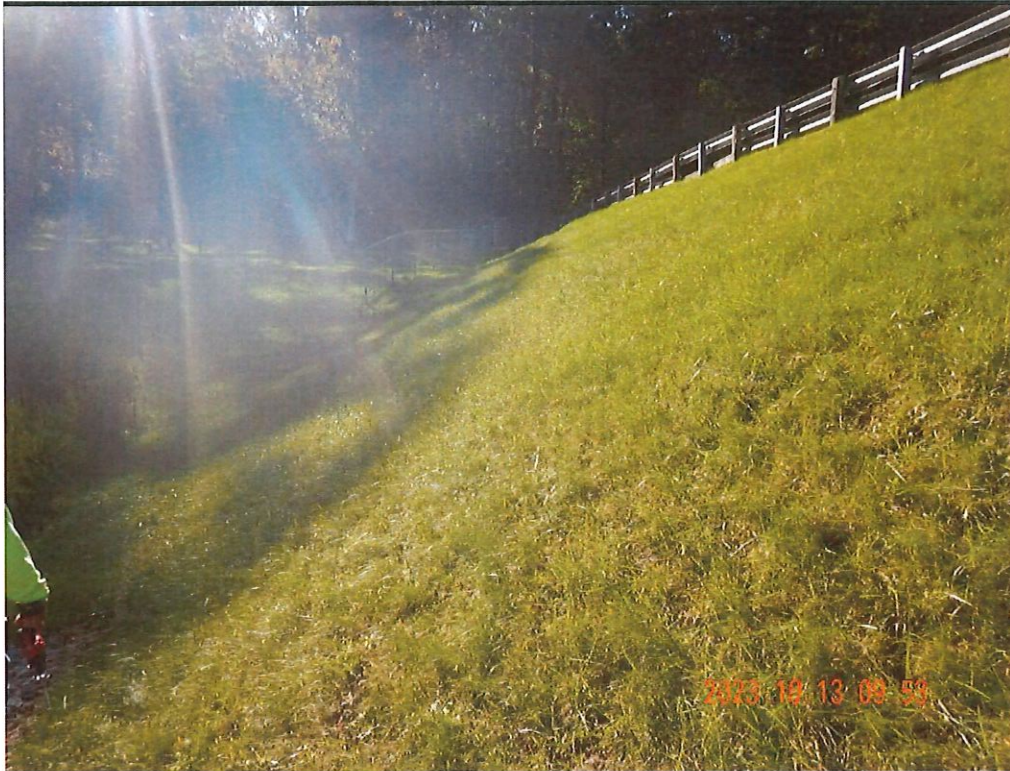
Photo 8 description: Downstream Slope Right Side

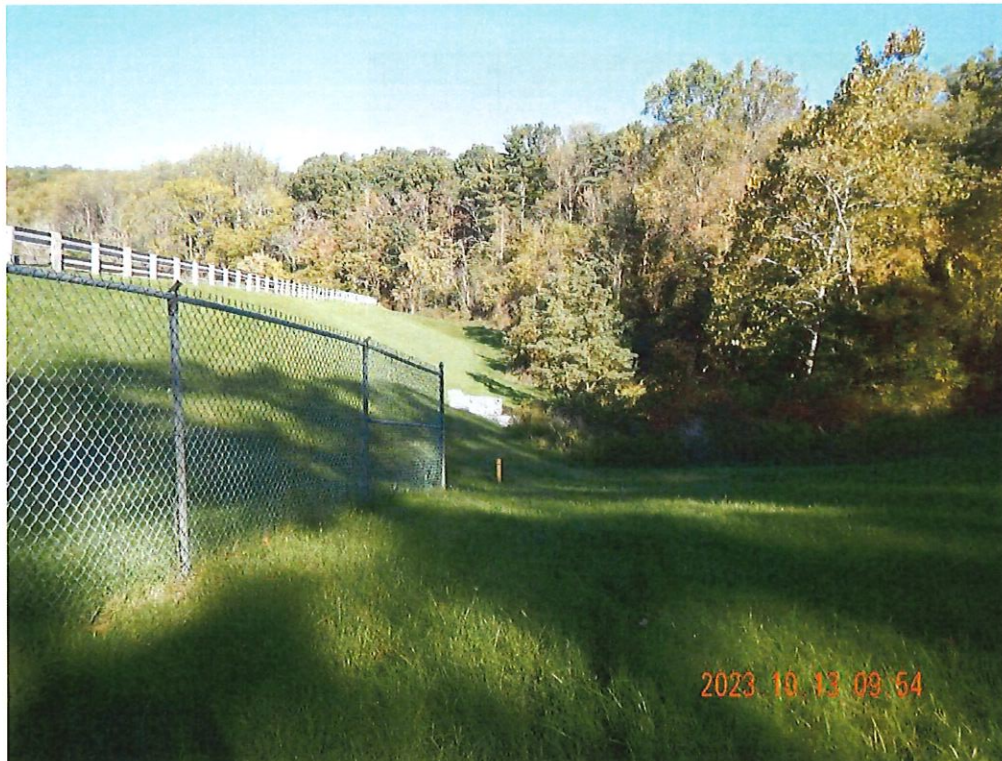
Photo 9 description: Downstream Slope Right Abutment

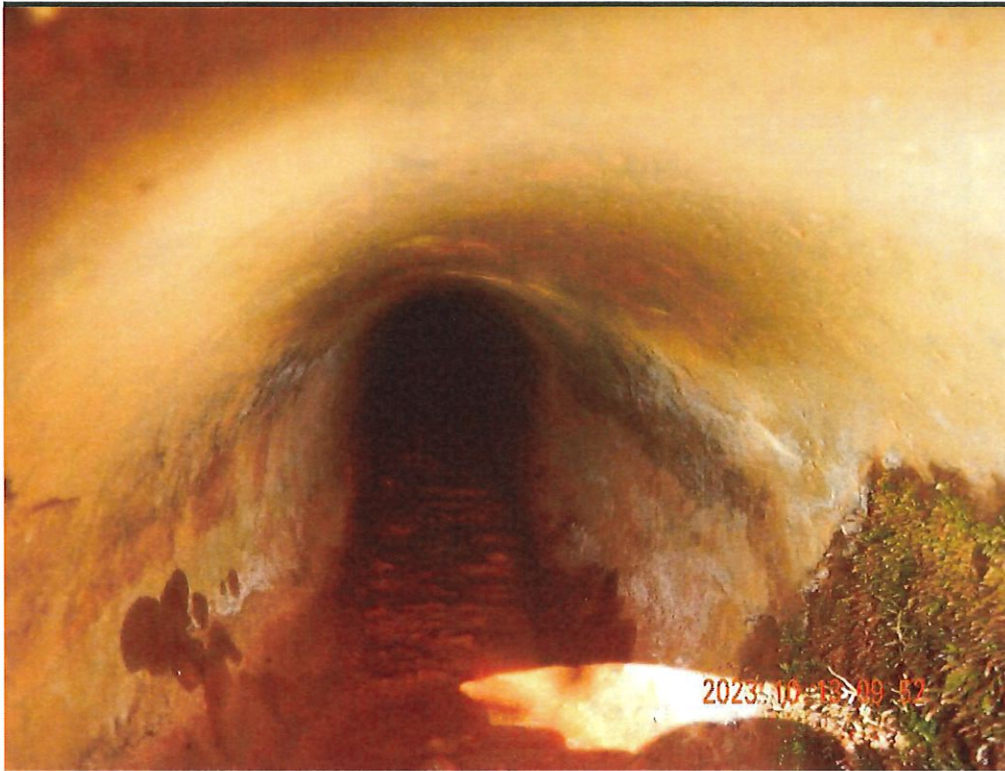
Photo 10 description: Left Filter Toe Drain Outlet

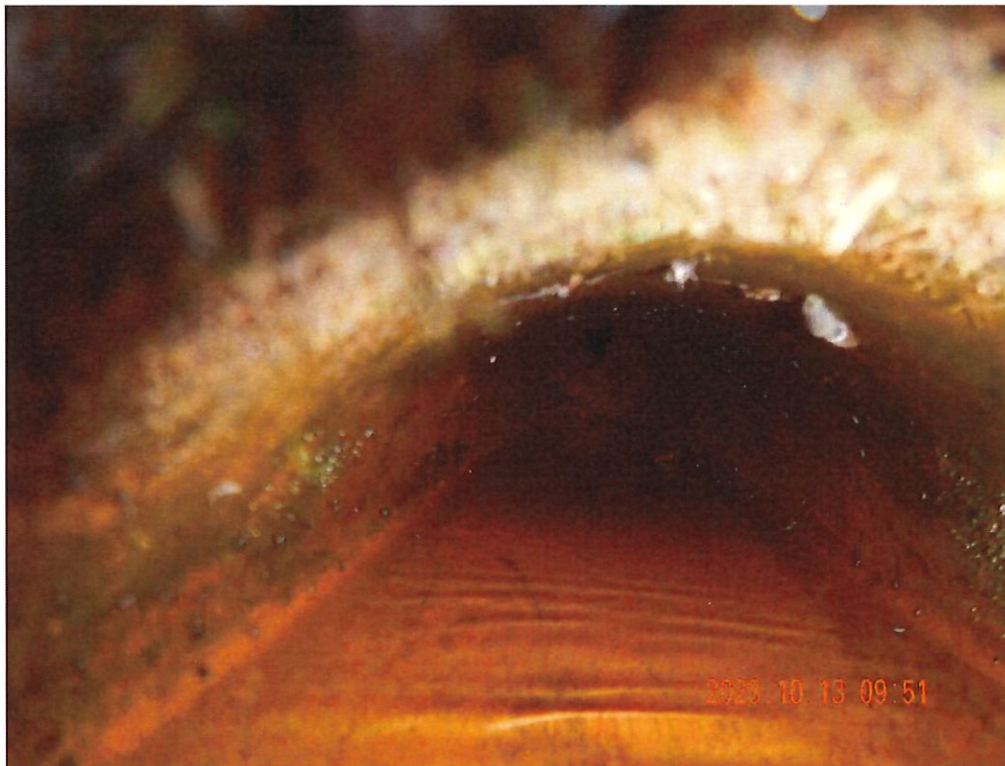
Photo 11 description: Right Filter Toe Drain Outlet

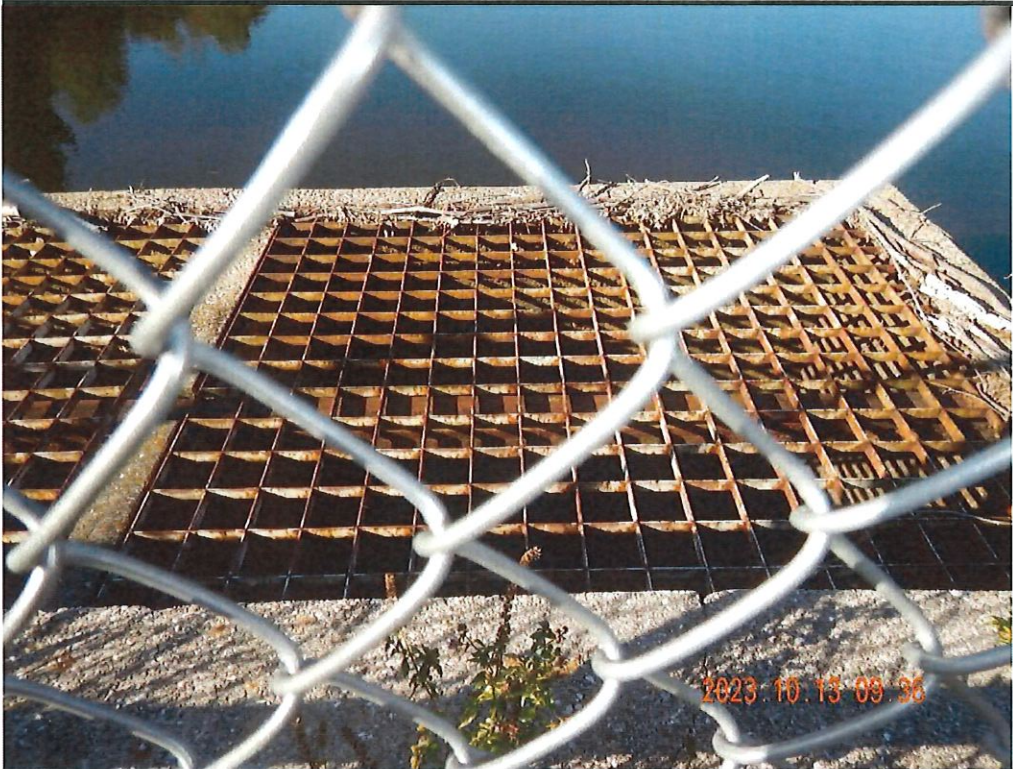
Cracks: A few on both the transition spillways of the front walls of the left and right sides weir wall.

Photo 12 description: Left Gate/Weir Wall

Describe action required: Please retain a professional engineer experienced in dam inspections, design and construction to evaluate the concrete condition and make recommendations.

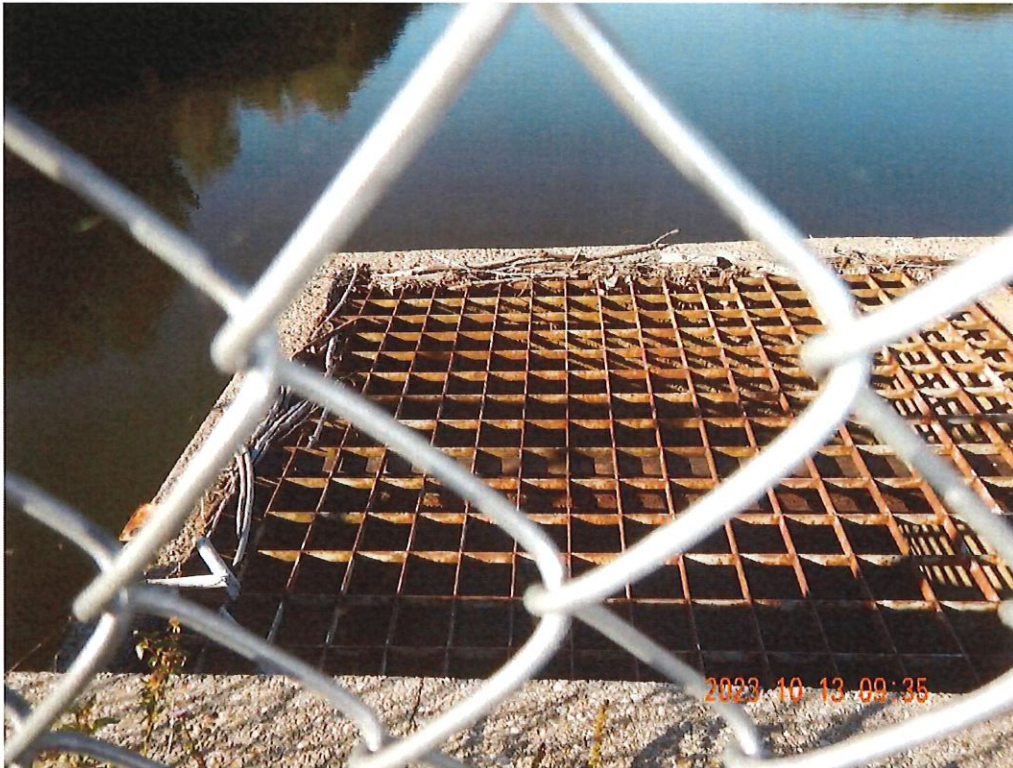
Spalling: Spot on the right wall of the right half of weir spillway and a few localized spots on the walls of the right and left box spillways.

Photo 13 description: Right Gate/Wier Wall

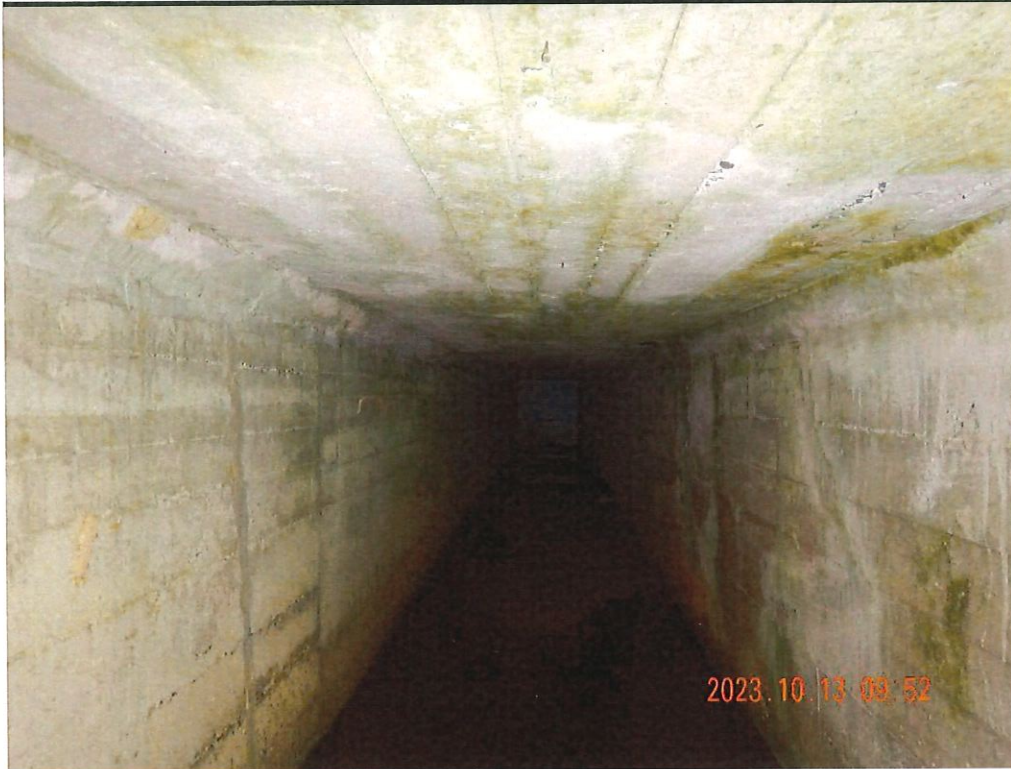
Photo 14 description: Interior Left Spillway

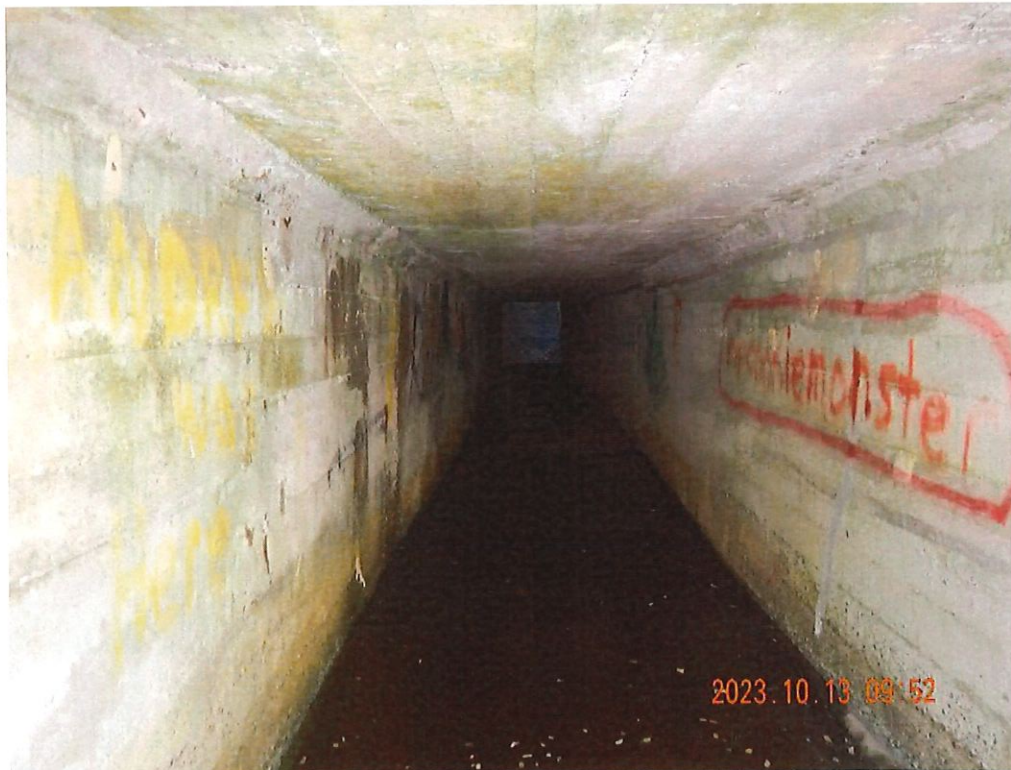
Photo 15 description: Interior Right Spillway

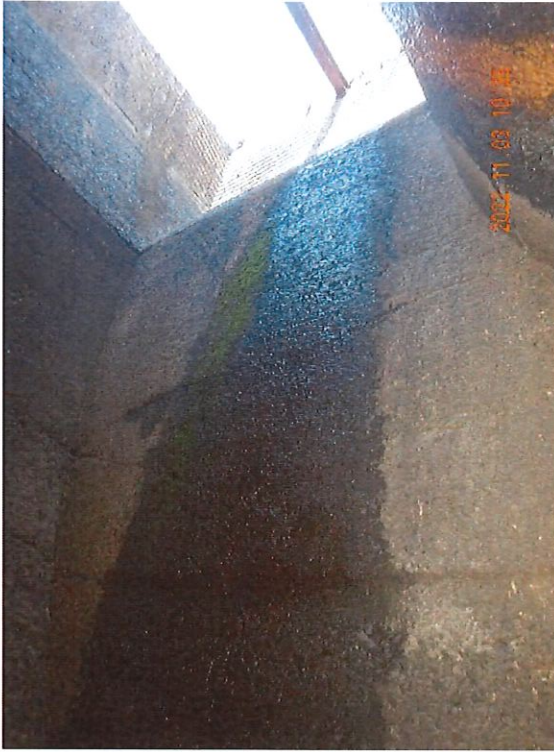
Photo 16 description: Left Side Interior Left Riser Box

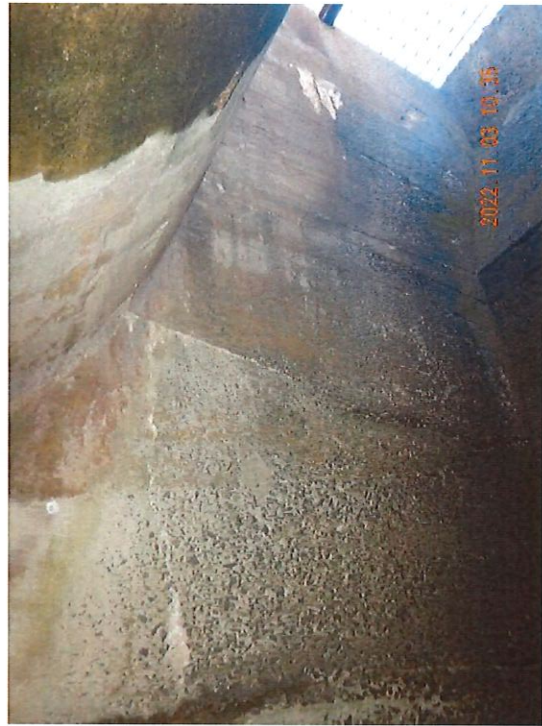
Photo 17 description: Right Side Interior Left Riser Box

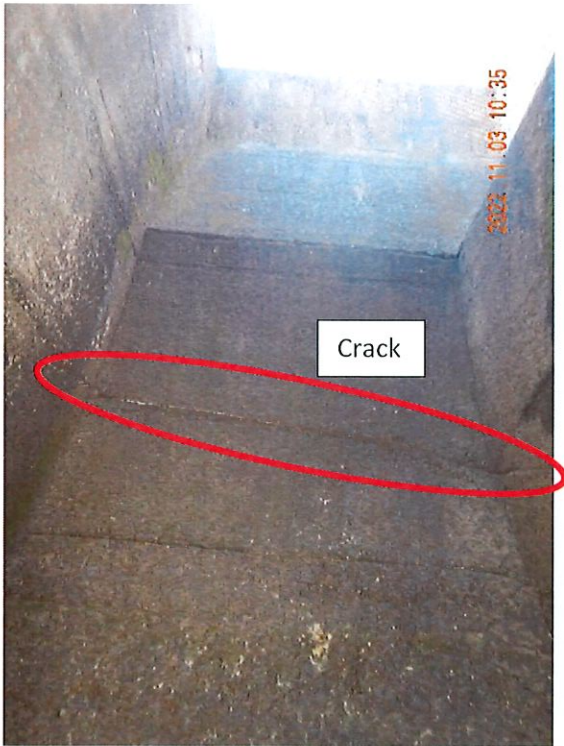
Photo 18 description: Front Side Interior Left Riser Box

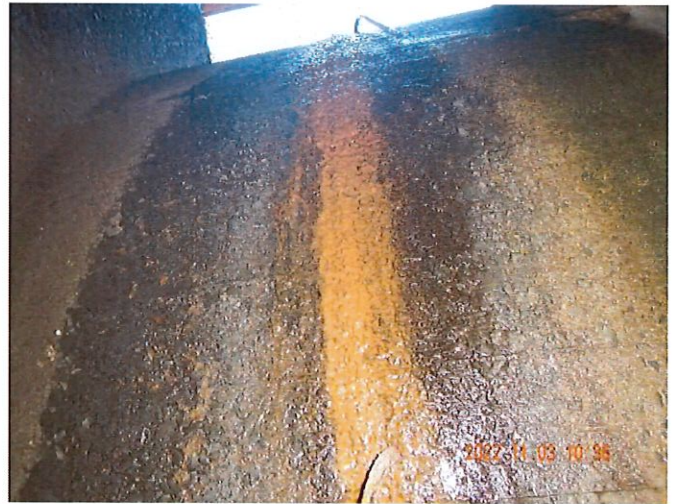
Photo 19 description: Back Side Interior Left Riser Box

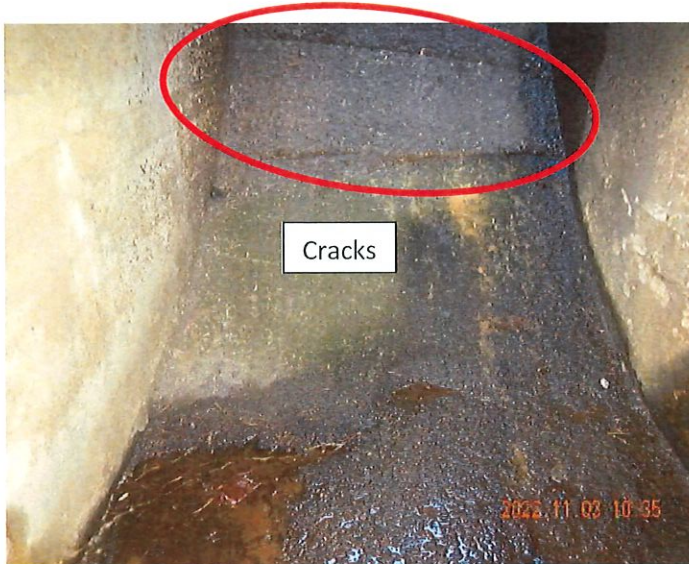
Photo 20 description: Transition Interior Left Spillway to Box Spillway

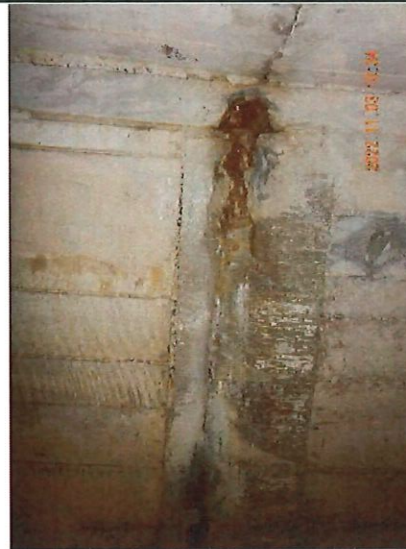
Photo 22 description: Seepage Point Left Side Interior Left Box Spillway

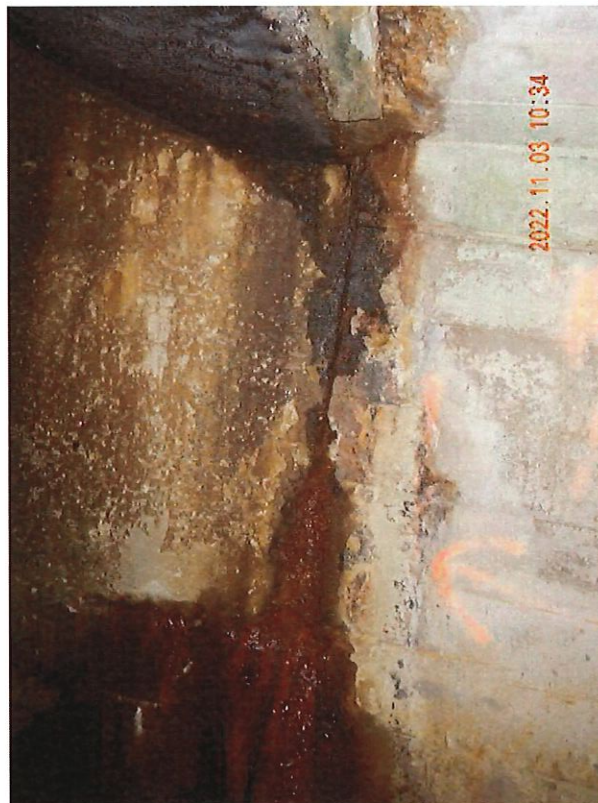
Photo 21 description: Seepage at Joint Between Left Riser Box and Left Box Spillway (Left Side)

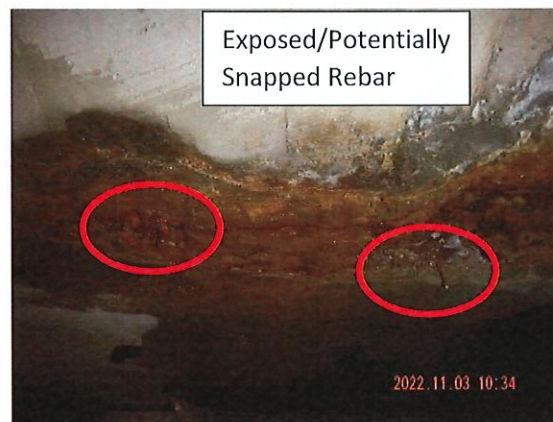
Photo 23 description: Seepage and Broken Rebar near Joint Between Back Wall Left Riser Box and Left Box Spillway

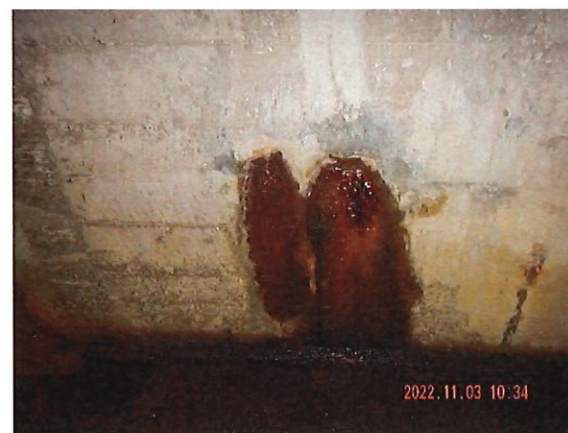
Photo 24 description: Seepage Point Left Side Interior Left Box Spillway

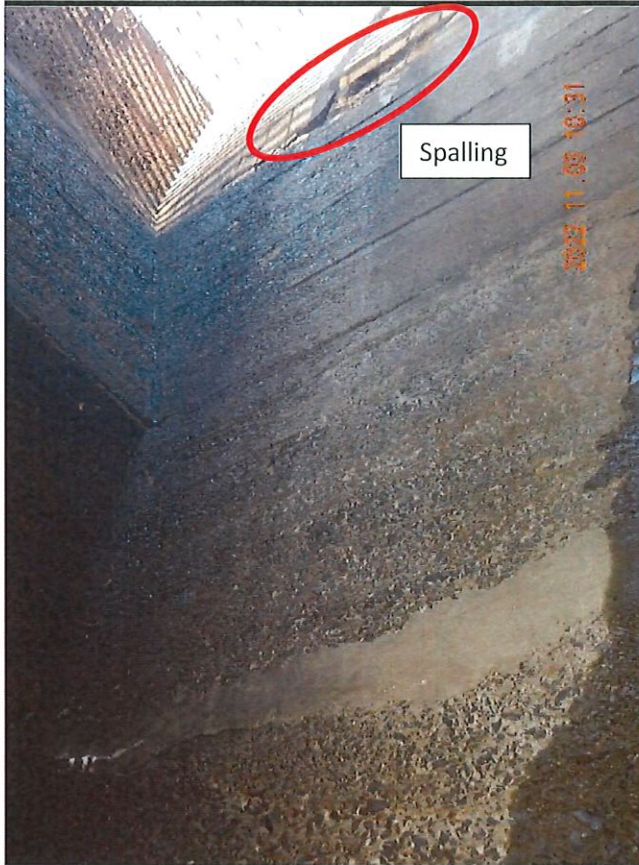
Photo 25 description: Left Side Interior Right Riser Box

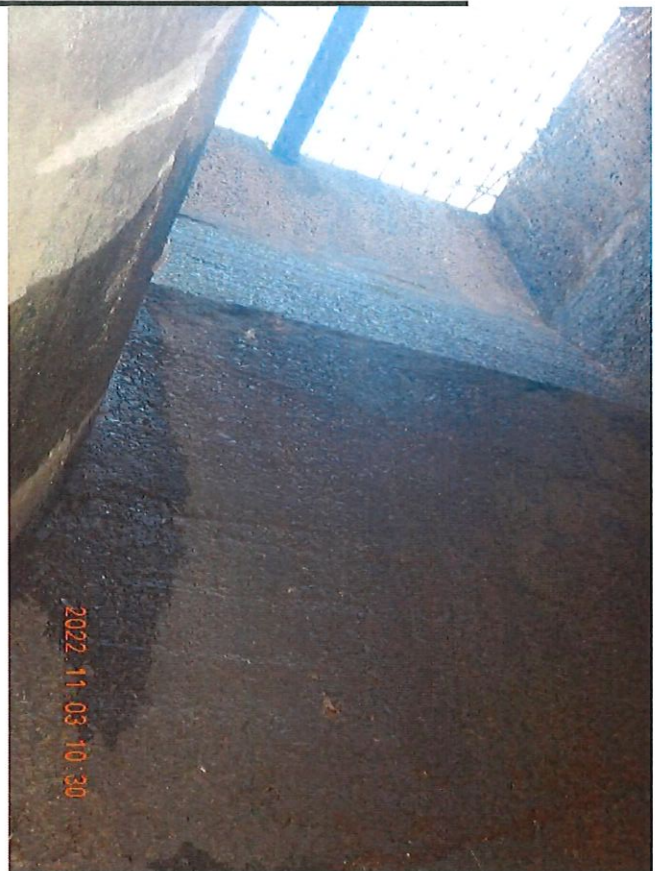
Photo 26 description: Right Side Interior Right Riser Box

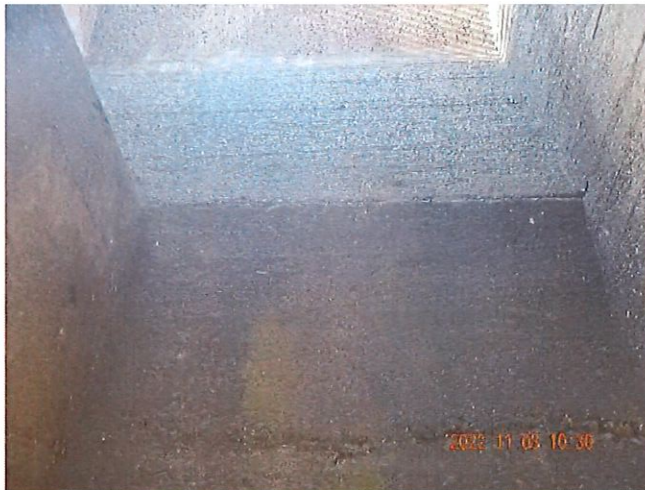
Photo 27 description: Front Side Interior Right Riser Box

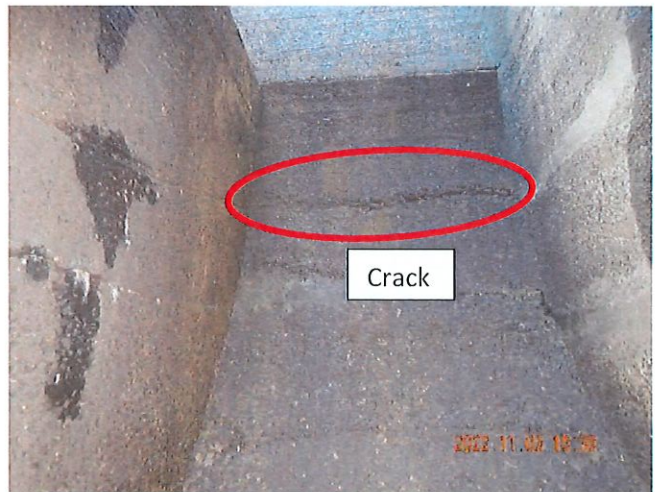
Photo 28 description: Transition Interior Right Spillway to Right Box Spillway

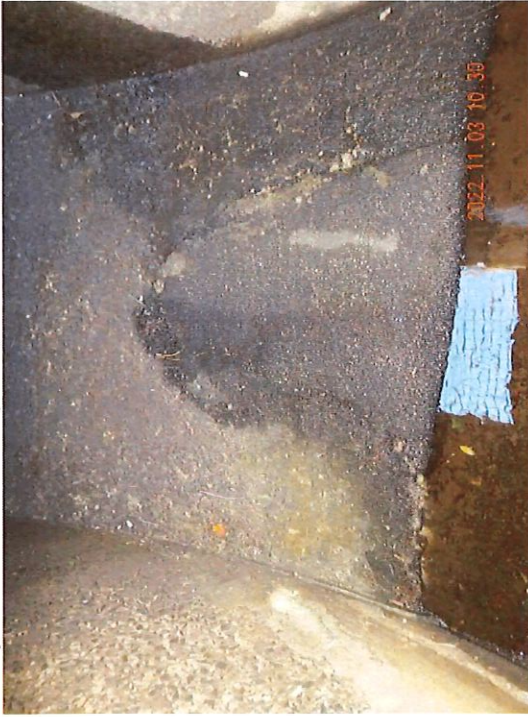
Photo 29 description: Transition Interior Right Spillway to Right Box Spillway

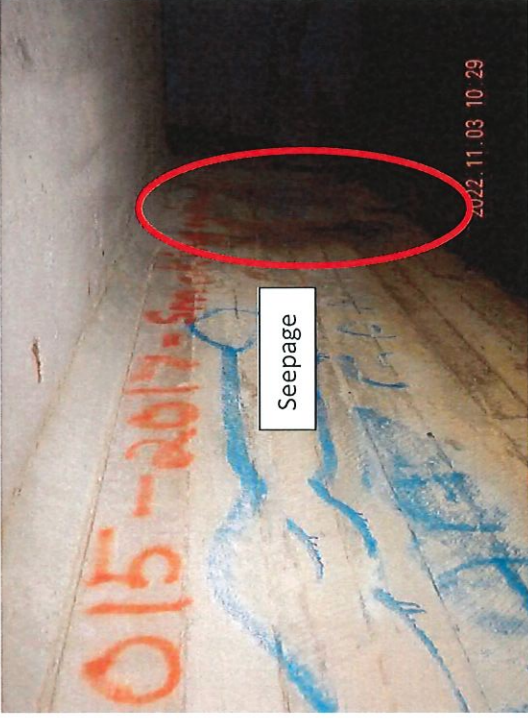
Photo 31 description: Seepage at Joints Right Box Spillway (Right Side)

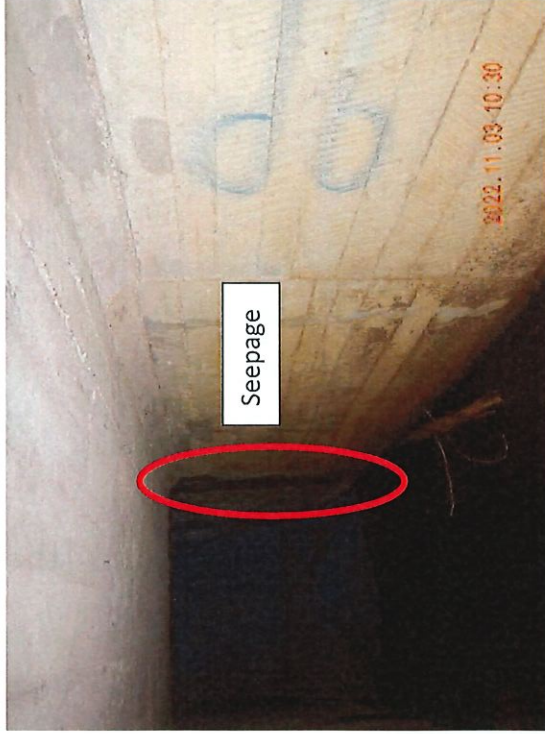
Photo 30 description: Seepage at Joint Between Right Riser Box and Left Box Spillway (Left Side)

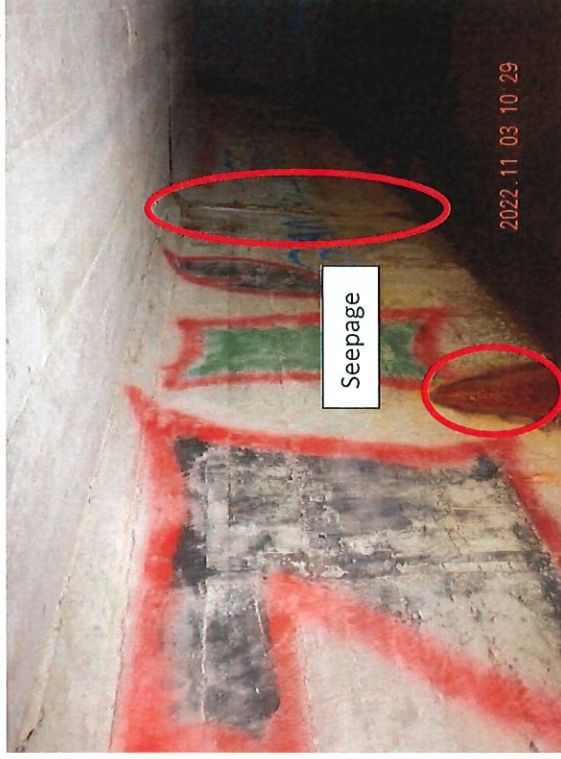
Photo 32 description: Seepage Point Right Box Spillway (Right Side)

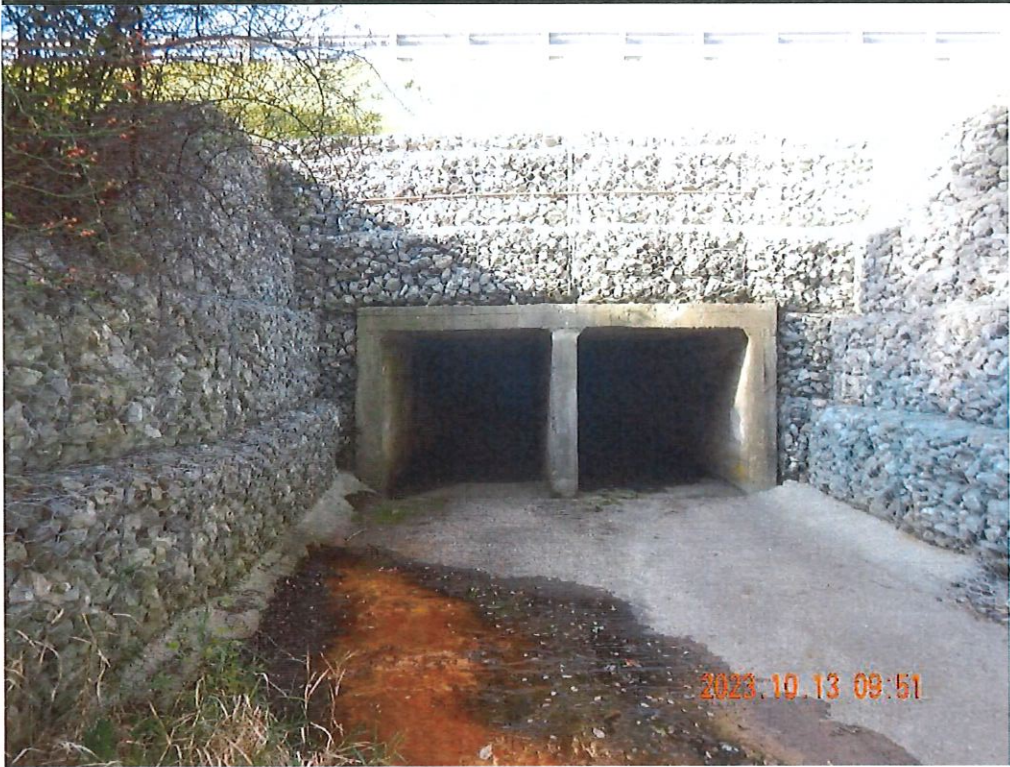
Photo 33 description: Principal Spillway Outfall/Gabion Basket Endwall

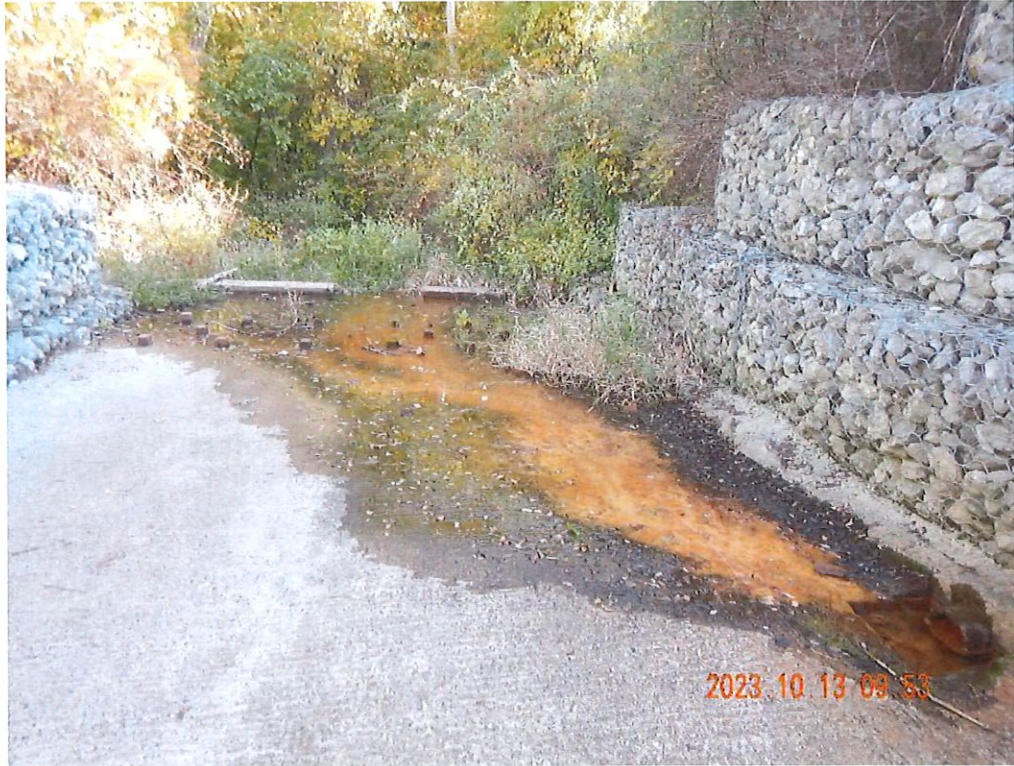
Photo 34 description: Baffle Blocks and End Sill

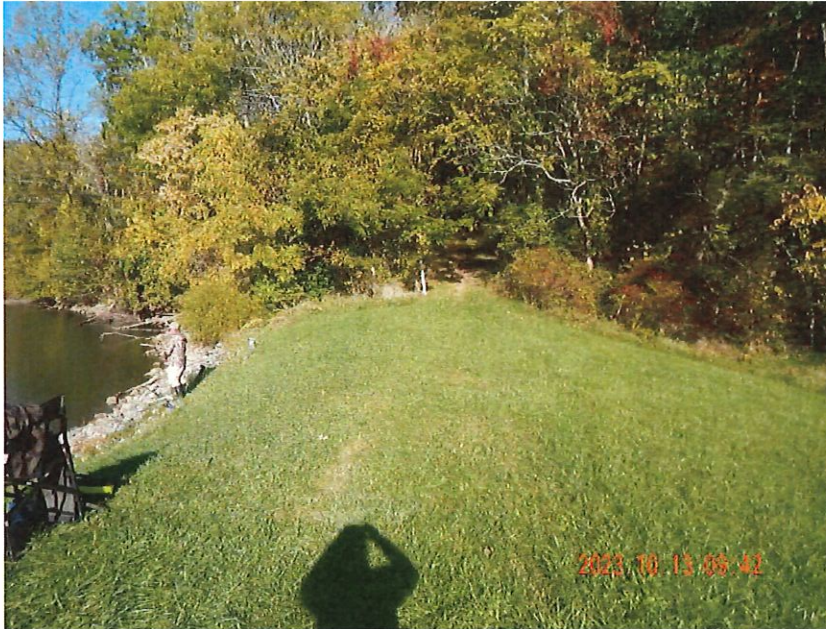
Photo 35 description: Auxiliary Spillway Control Section

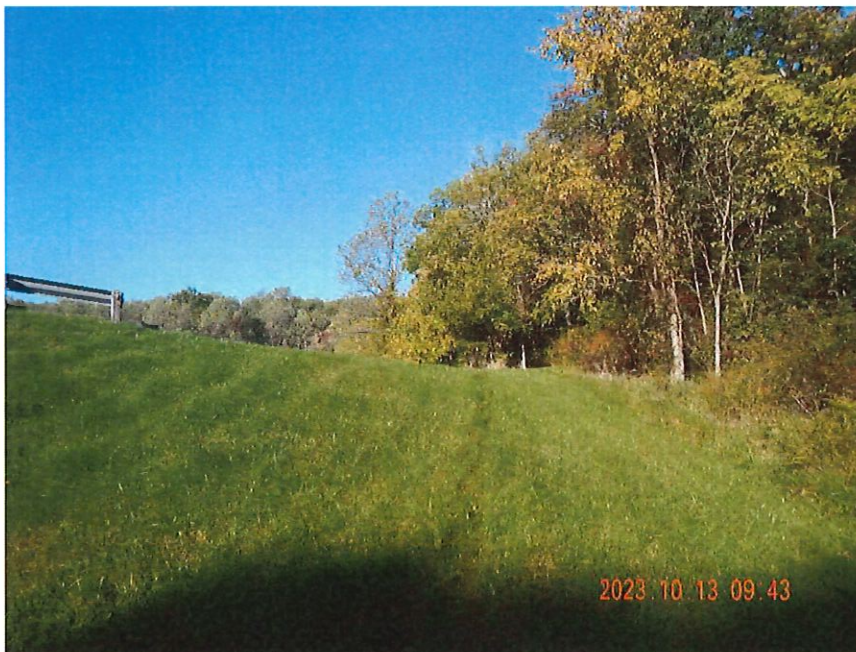
Photo 36 description: Auxiliary Spillway Exit Channel

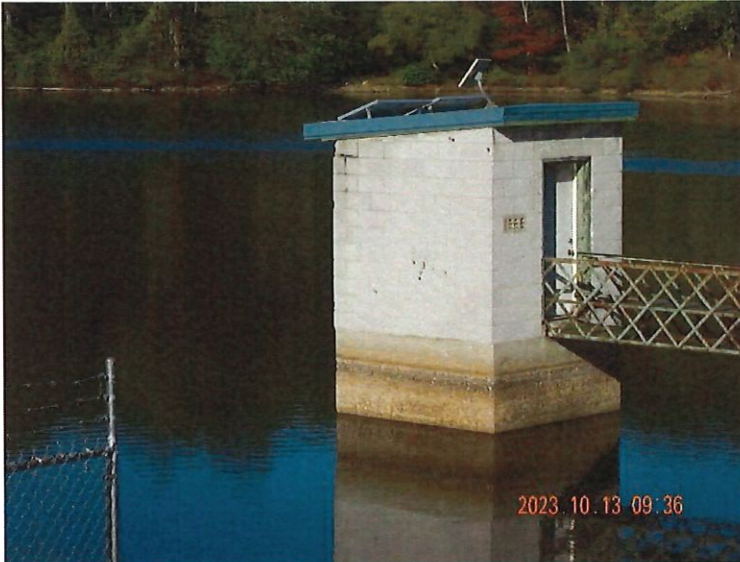
Photo 37 description: Control Tower Exterior

Describe action required: Please perform any routing maintenance of the valves and exercise operable valves at a minimum annually. Please retain a professional engineer experienced in dam inspections, design and construction to evaluate the water control tower and gates/valves condition and make recommendations.

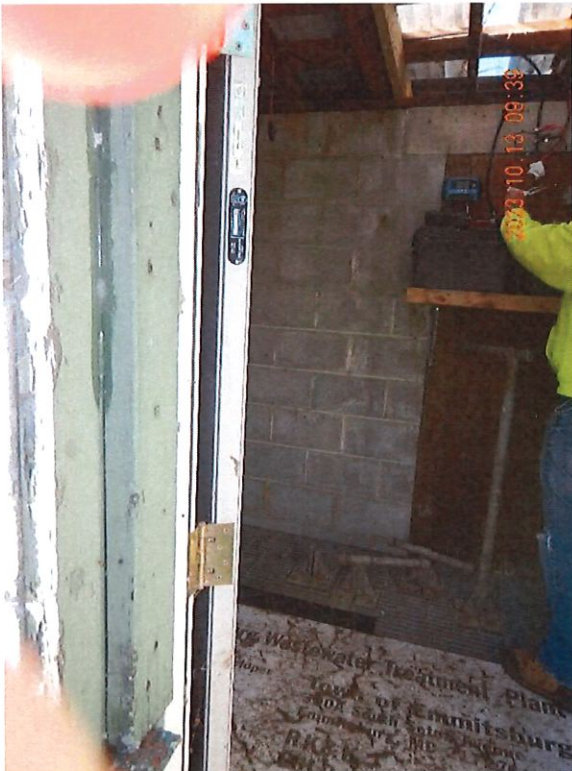
Photo 38 description: Interior Control Tower

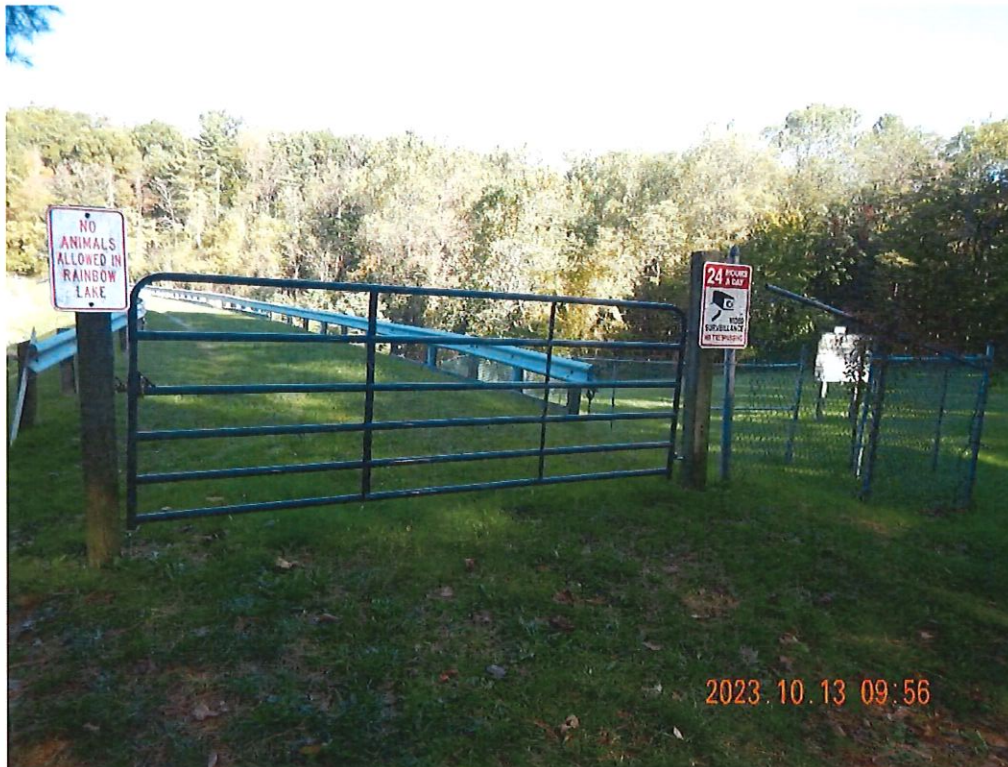
Photo 39 description: Warning Signs and Locked Gate at Access to the Dam Crest

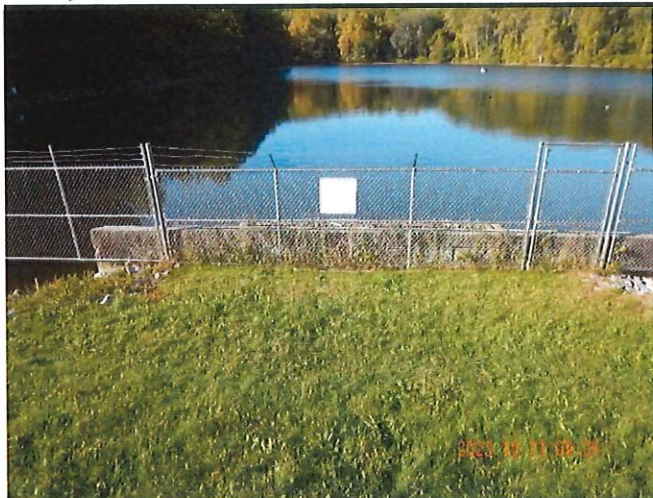
Photo 40 description: Warning Sign on Safety Fence at Principal Spillway
