**Maryland**  
Department of  
the Environment

Subject: Dam Inspection Findings  
Emmitsburg Dam (MD Dam No. 18)

# **INSPECTION REPORT**

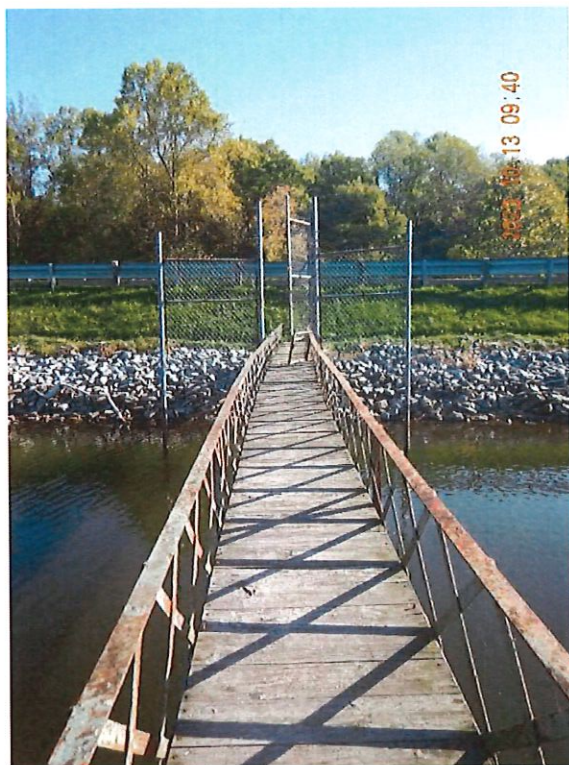
Photo 41 description: Locked Gate at Access Walkway to Intake Tower
